ROLL-ON/ROLL-OFF (RO/RO) DISCHARGE FACILITY TESTS
WITH MV CYGNUS AND SS ATLANTIC BEAR

(COTS CNO PROJECT 299, DT-IIF-1)

SYSTEMS DEVELOPMENT DEPARTMENT
RESEARCH AND DEVELOPMENT REPORT

NOVEMBER 1983

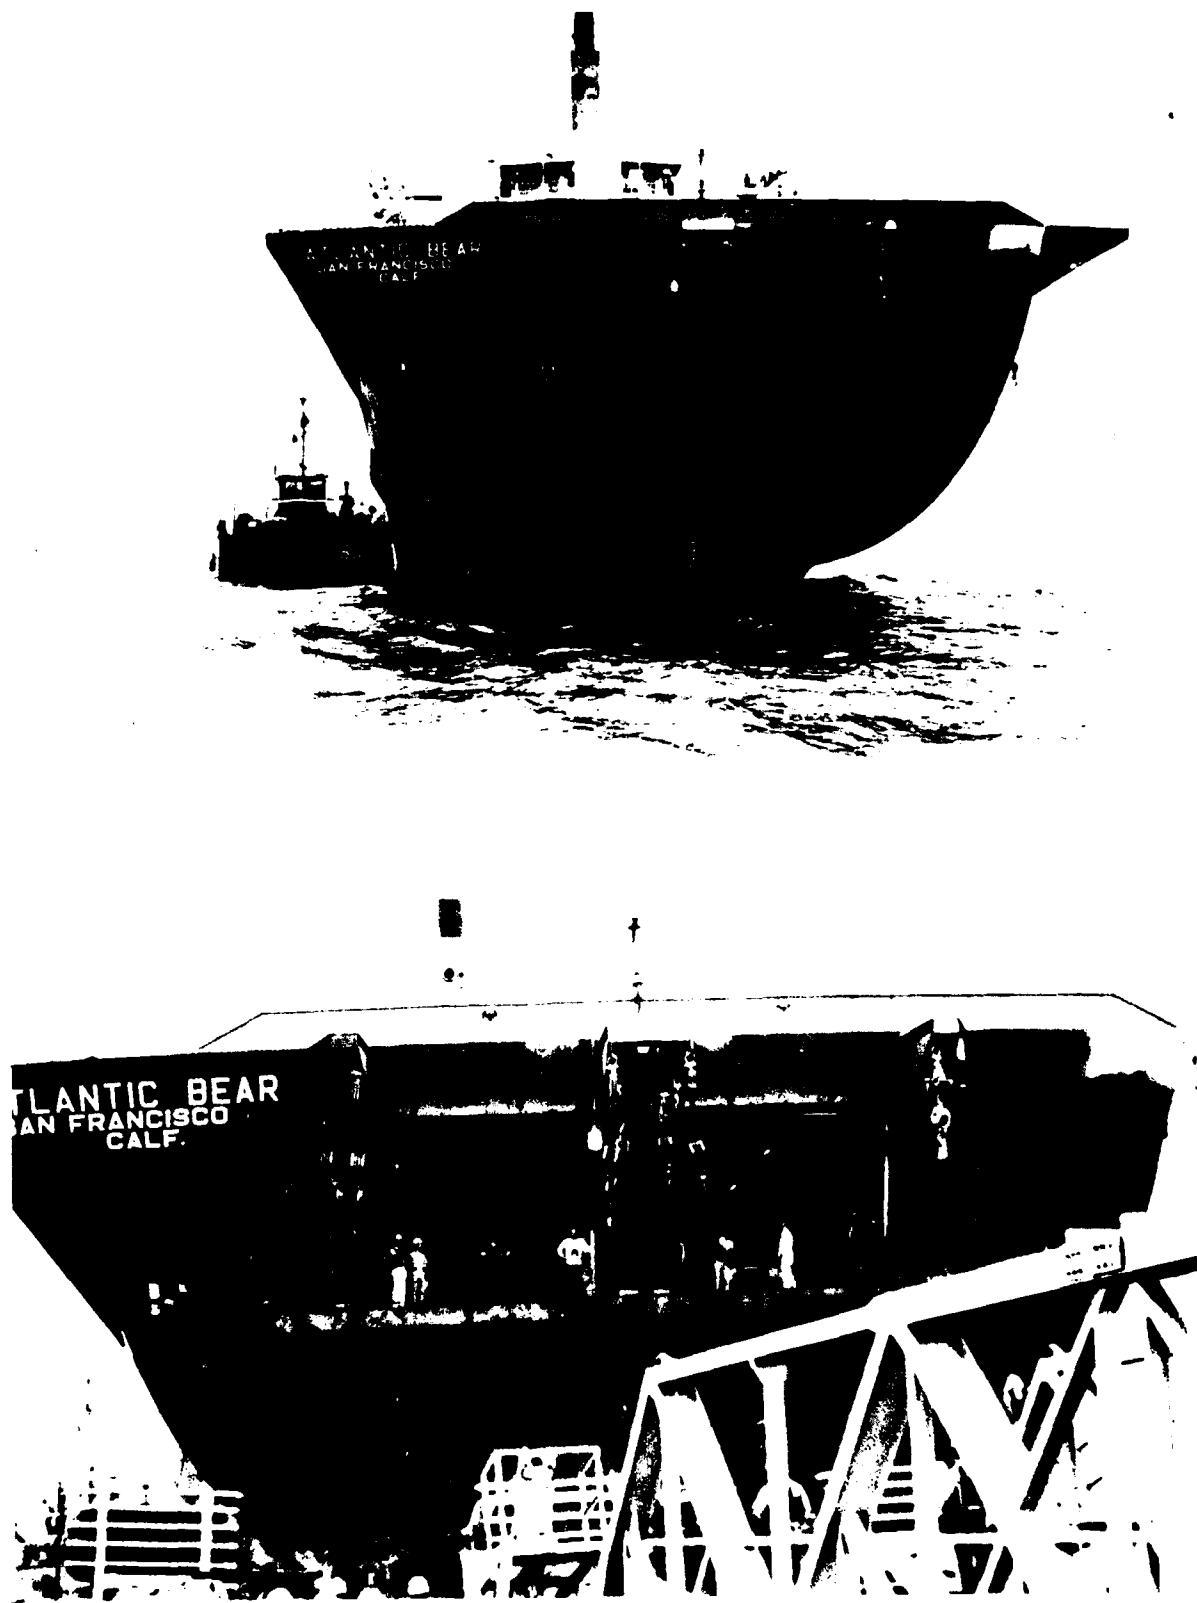
Figure 34 - CPF at Transom Port of SS ATLANTIC BEAR

with respect to ships' transom varied from 3 ft to 4 ft. Figure 34 shows this transom port arrangement. This clearly shows that given a choice, the transom port should be used instead of a side port. However, six of the ten nonself-sustaining ships have only side ports. For those ships, the aft side port is the preferred side port because of shipboard vehicle movement restrictions at both the mid-ship side port and forward side port. The mooring was then cancelled for the day so that repairs could be made to the fenders. As shown in Figure 35 the fender assemblies were modified by attaching the fenders directly to the support frame and grease was applied to reduce friction forces. Successful mooring operations were carried out on 17 and 20 September. The approved mooring procedure and arrangement is shown in Figure 36.

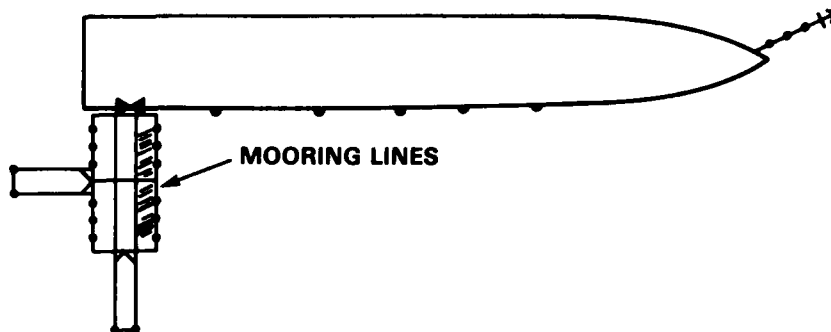
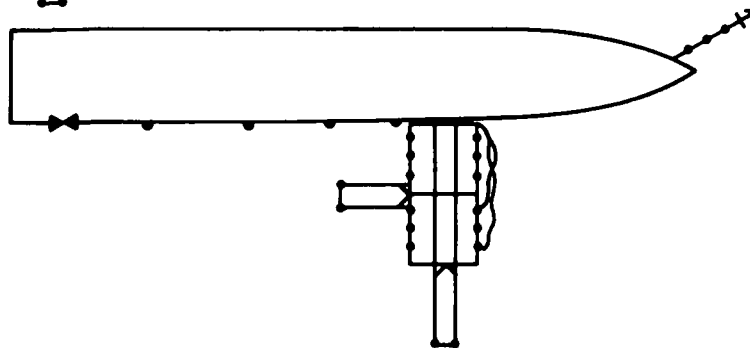
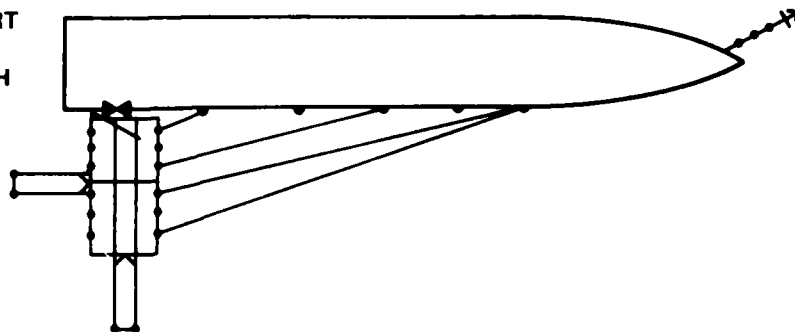
Figure 36 - CPF Mooring Procedure to SS ATLANTIC BEAR's Aft Side Port

1. SHIP ANCHORED (PORT ANCHOR)
CPF IS POSITIONED BENEATH PORT
MOORING LINES ARE PASSED TO CPF

2. CPF MOVED FORWARD BY WARPING TUGS
TWO LINES ARE PASSED TO SHIP'S BITT
FROM CPF'S BOLLARDS

3. CPF IS MOVED AFT, KEEPING TENSION
ON MOORING LINES.
REMAINING TWO LINES ARE CONNECTED
TO SHIP'S RECESSED BOLLARDS AS
SHOWN

4. CPF IS MOVED AFT TO OFFLOADING PORT
TWO LINES ARE PASSED TO CPF FROM
SHIP AS SHOWN AND TIGHTENED WITH
WINCH
REMAINING LINES ARE TIGHTENED
WITH WARPING TUG WINCH AS
REQUIRED

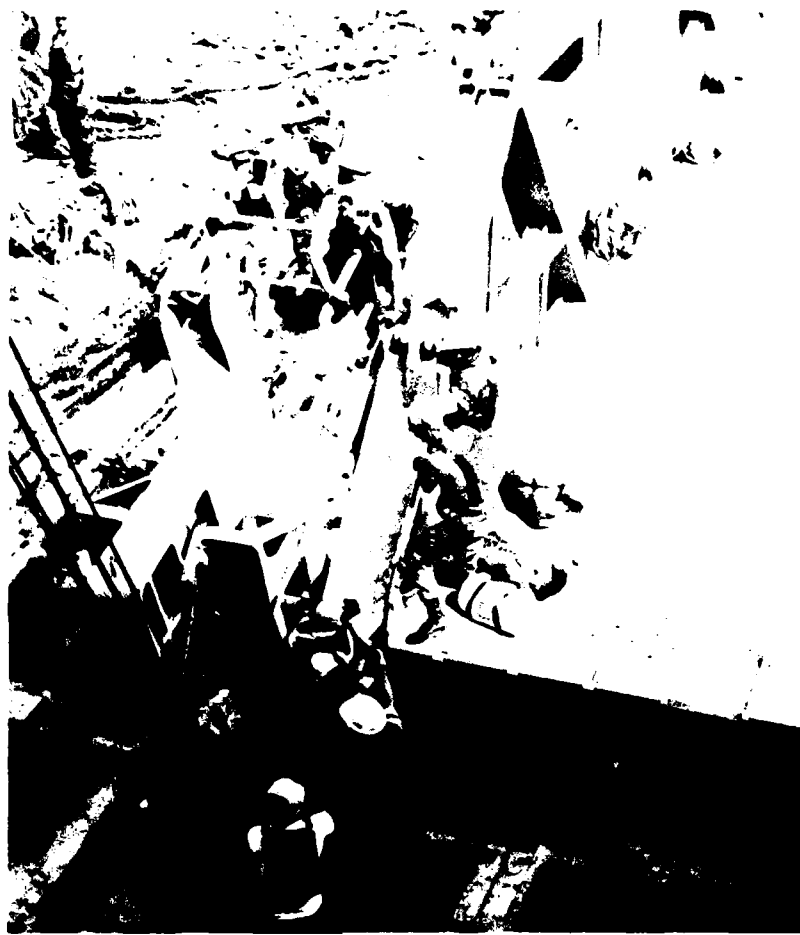
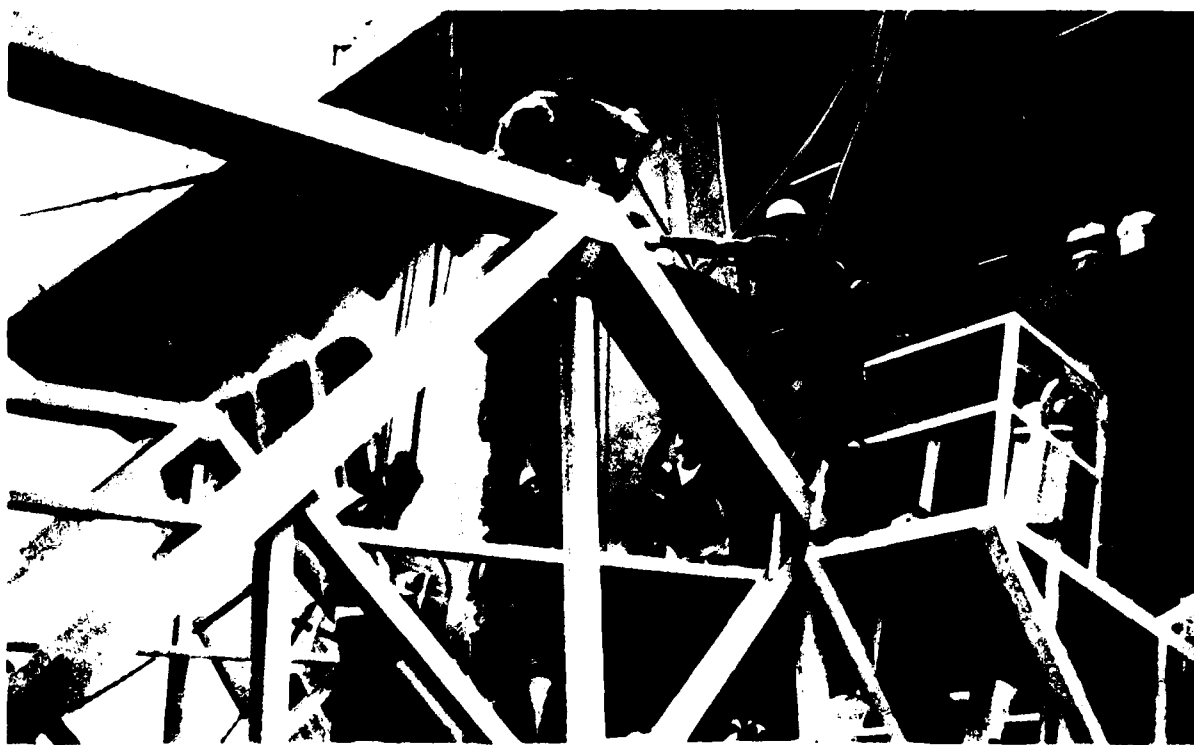
Figure 40 - Connecting CWR Drag Blocks

b. Connecting the drag and lift blocks was awkward, difficult, and somewhat dangerous as there was no easy way to bring them to the CWR shackles (Figure 40).

2. Raising and securing the CWR to the ship can be enhanced by lengthening the ship's drag cables so as to eliminate the need for the 15 ft long extension pendants (a drag block tackle extension capability of at least 55 ft is required).

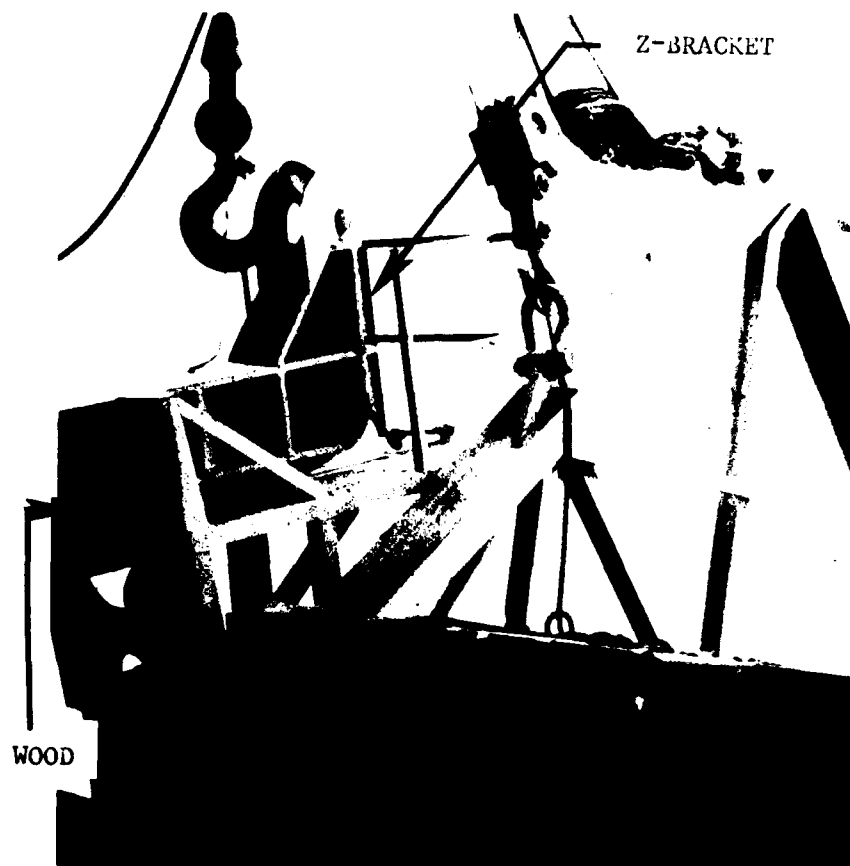
Figure 41 - Wood Wedged Against Z-Bracket

e. A considerable delay was encountered when removing a piece of wood jammed against one of the Z-brackets in its support (Figure 41).

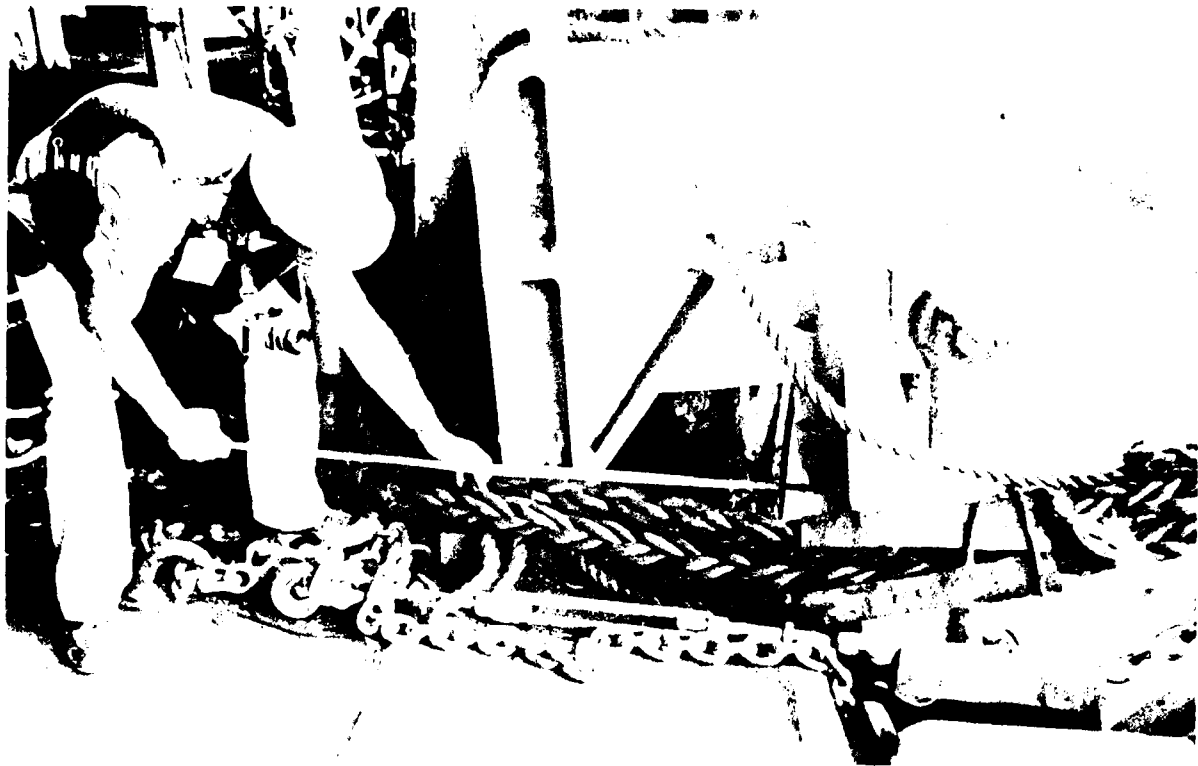
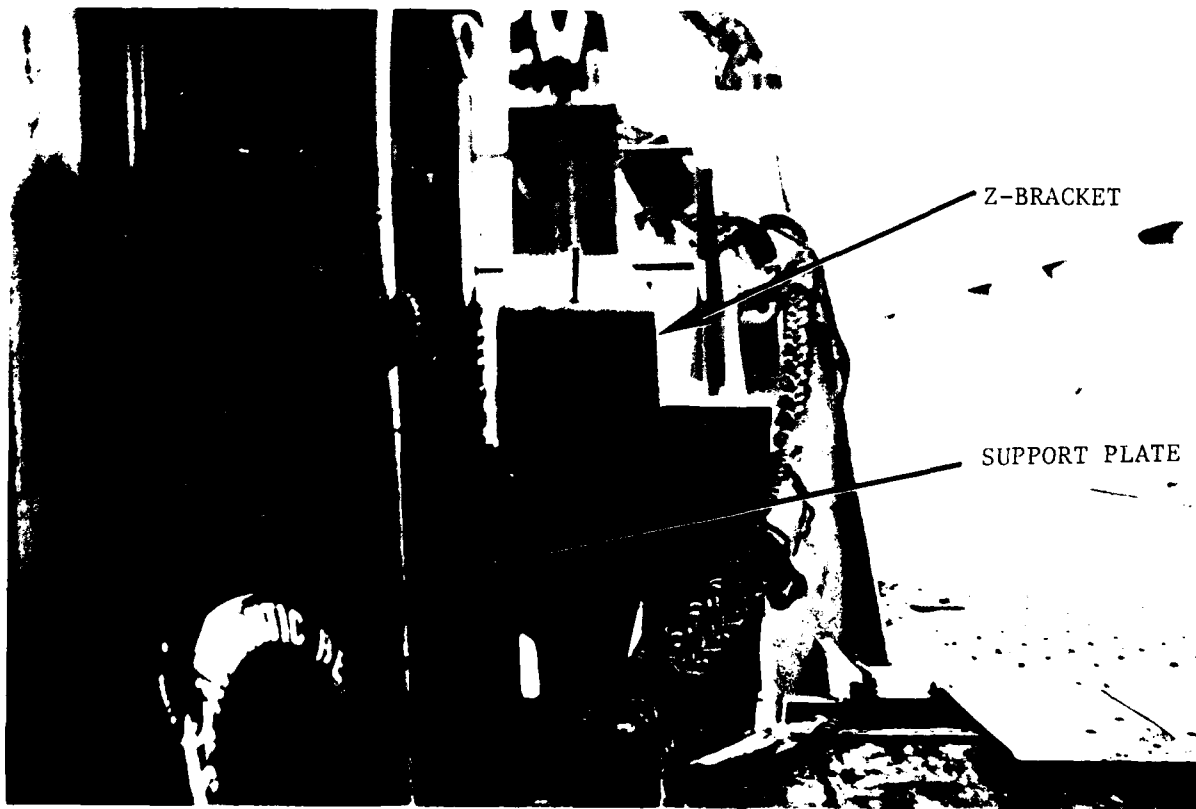
Figure 43 - Z-Bracket/Hemanski Hook Interface

- b. The Z-Brackets rubbed against the support plate for the conventional ship's ramp (Figure 43).

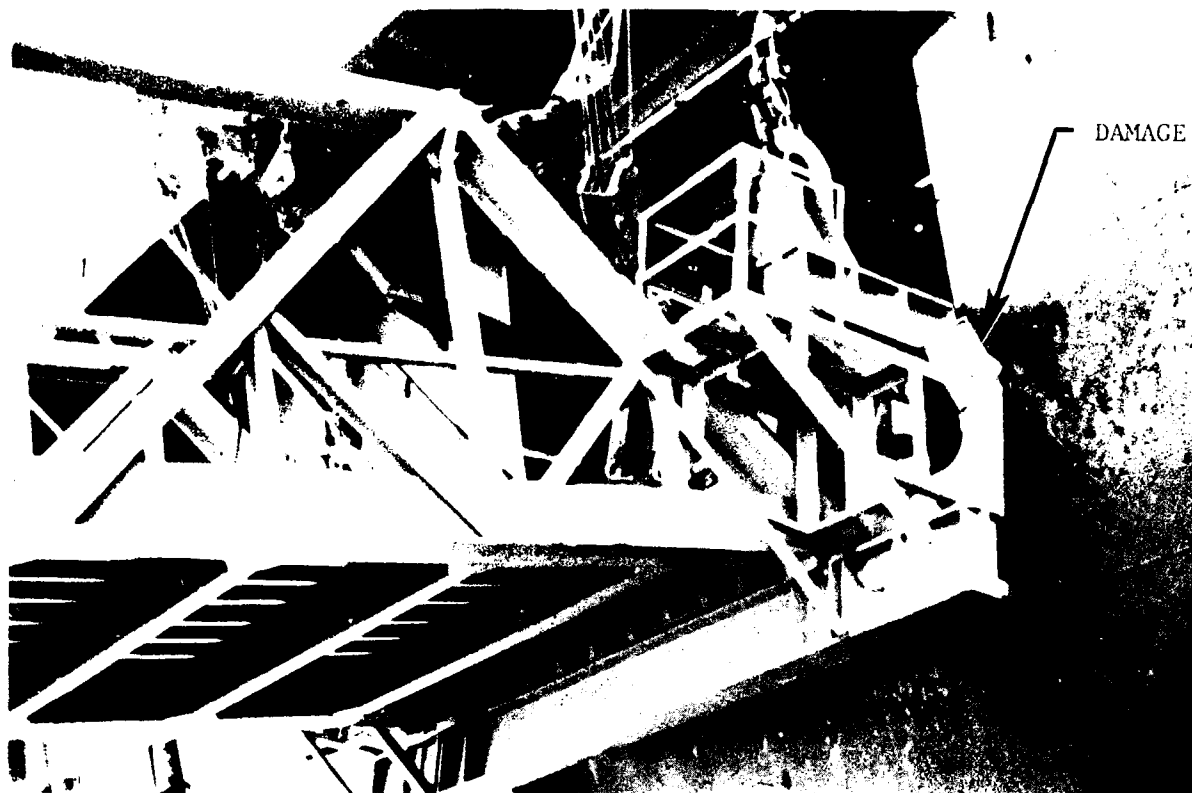
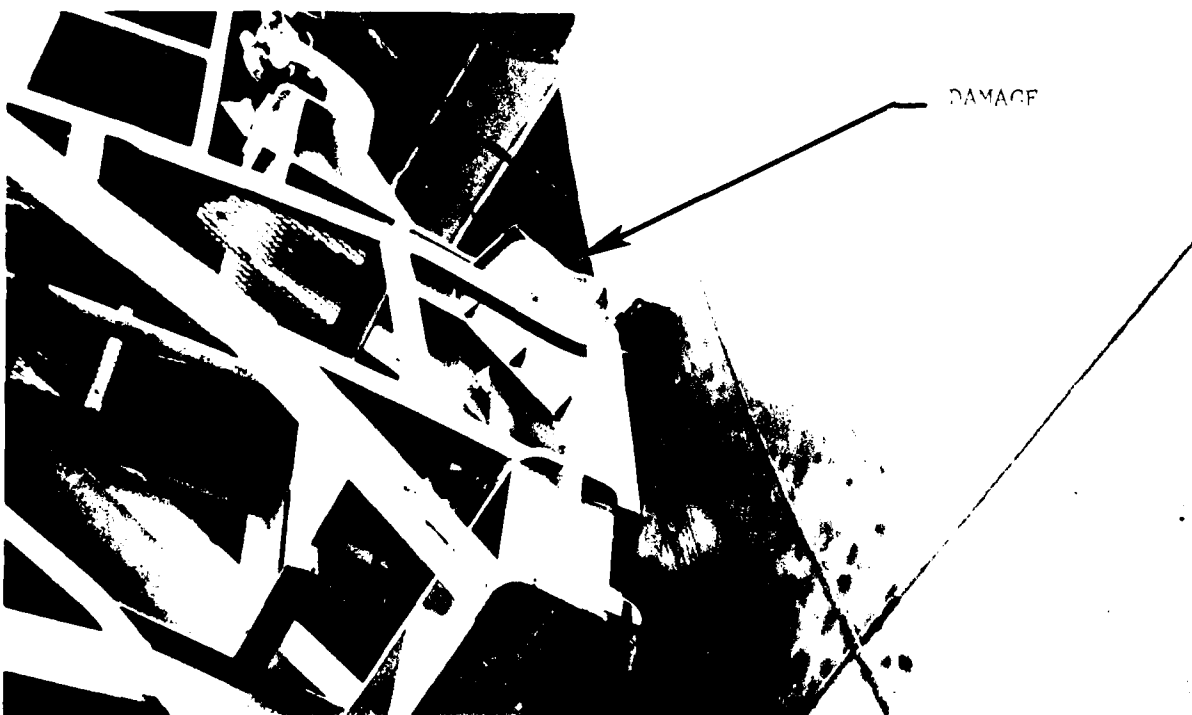
Figure 44 - CWR - Personnel Platform Damage

- c. The Z-bracket/support pendant system allowed as much as 5 degrees of "rotation" of the ramp. This resulted in damage to the CWR's Z-bracket support/personnel platform (Figure 44).

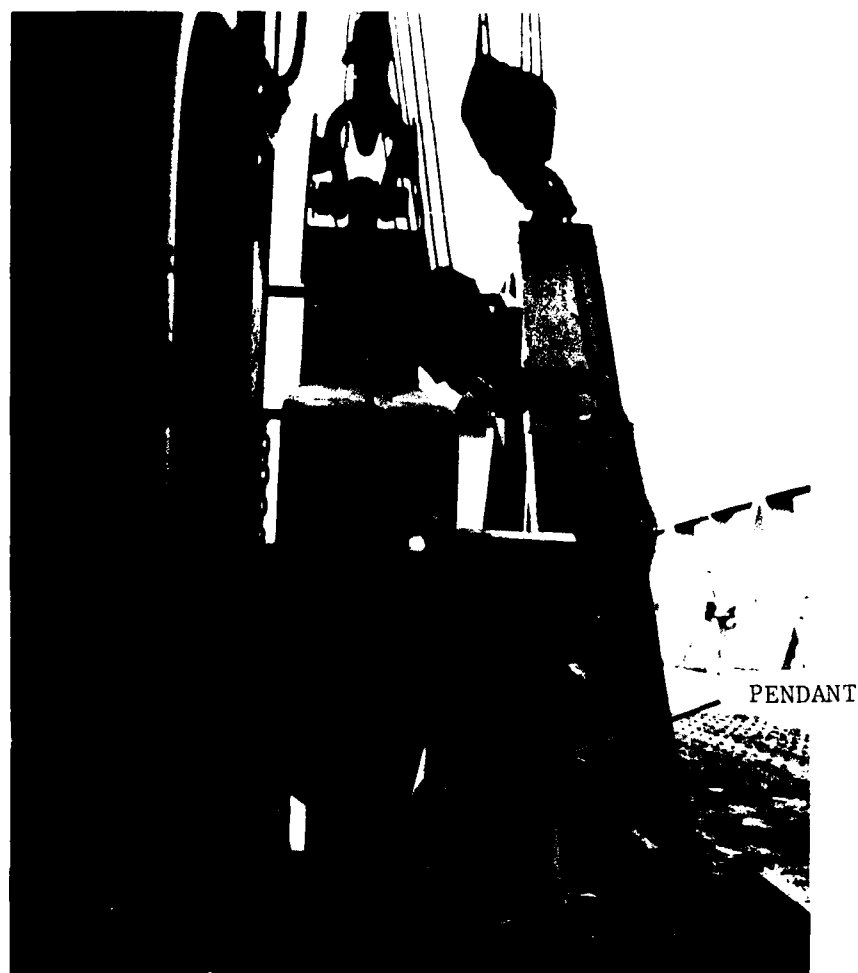
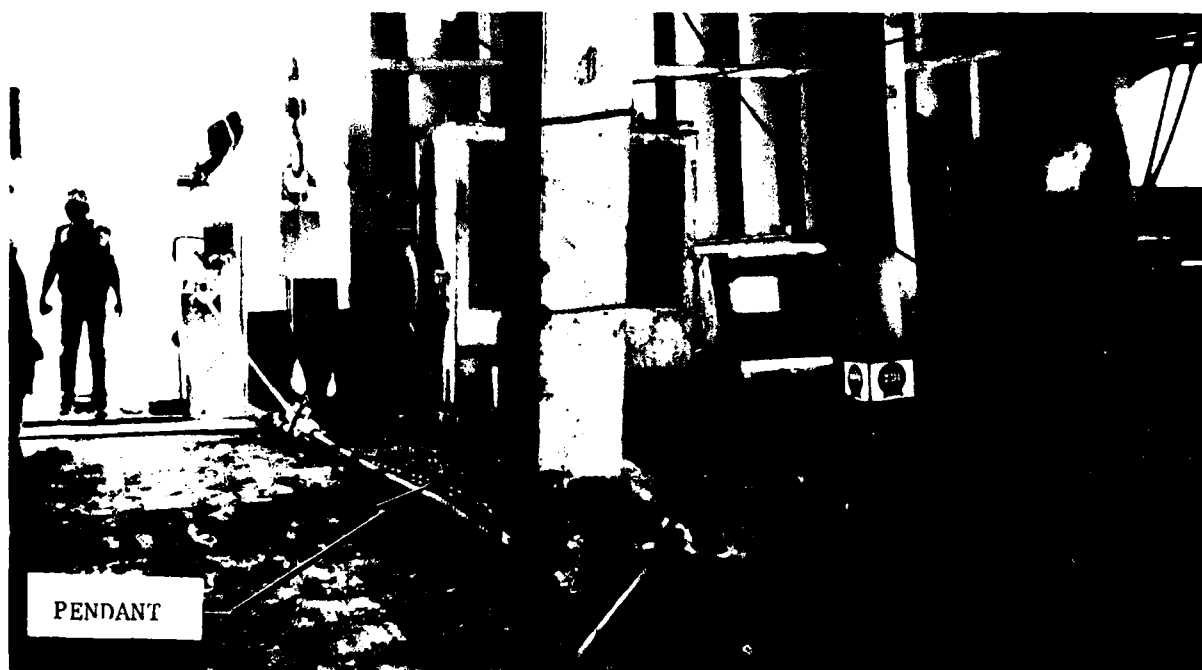
Figure 45 - Ship/CWR Pendant

- d. A temporary set of pendants was rigged from the ship to the ramp to prevent excessive ramp motion away from the ship (Figure 45).

- 2. By adding pendants between the CWR and ship to restrict CWR

horizontal motion away from the ship, the CWR can be supported and aligned safely in up to Sea State 2 conditions.

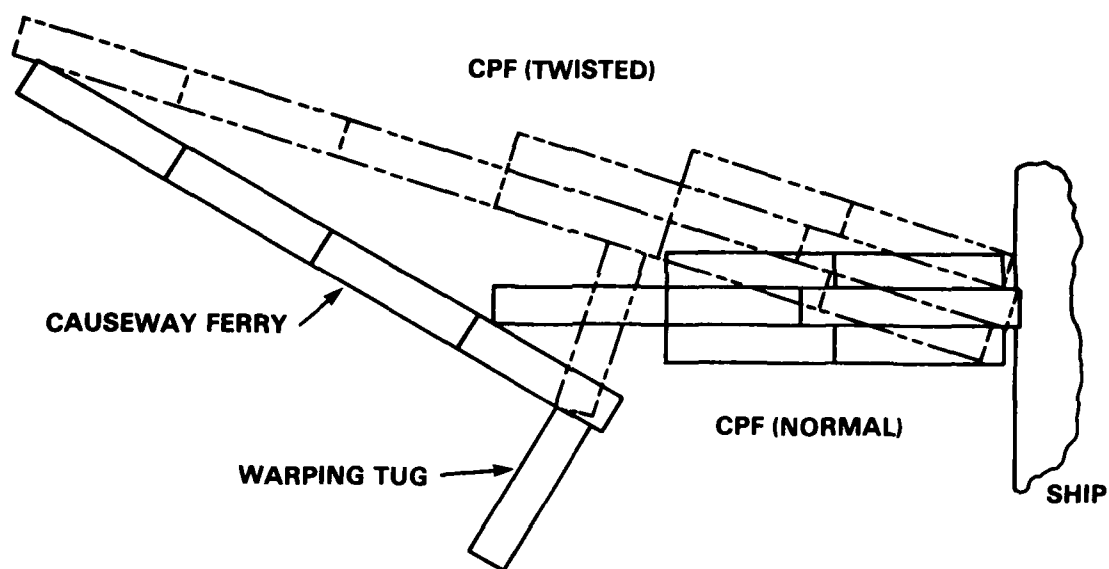
Figure 46 - CPF Rotation During Causeway Ferry Marriages

Test Results. As was expected and determined previously during CPF testing with the AMERICAN TROJAN⁵ Causeway Ferries and LCUs can readily marry to the platform in Sea State 0-1 with slight wind and current but LCUs are hampered by increasing sea state, wind, and current. One problem not previously noted was that when marrying Causeway Ferries to the platform it is possible to twist the platform beneath the offloading port (Figure 46). When this occurred one of the lift cables parted as it was overloaded under tension. The CWR, which was supported by the support pendants and Z-brackets, was not adversely affected.

2. Operational procedures have been improved following the test by:
 - a. Specifying in the technical manual the requirement for slacking the CWR lift and drag tackles (once the CWR is secured in place) sufficiently to avoid overloading them if the CWR is rotated severely.

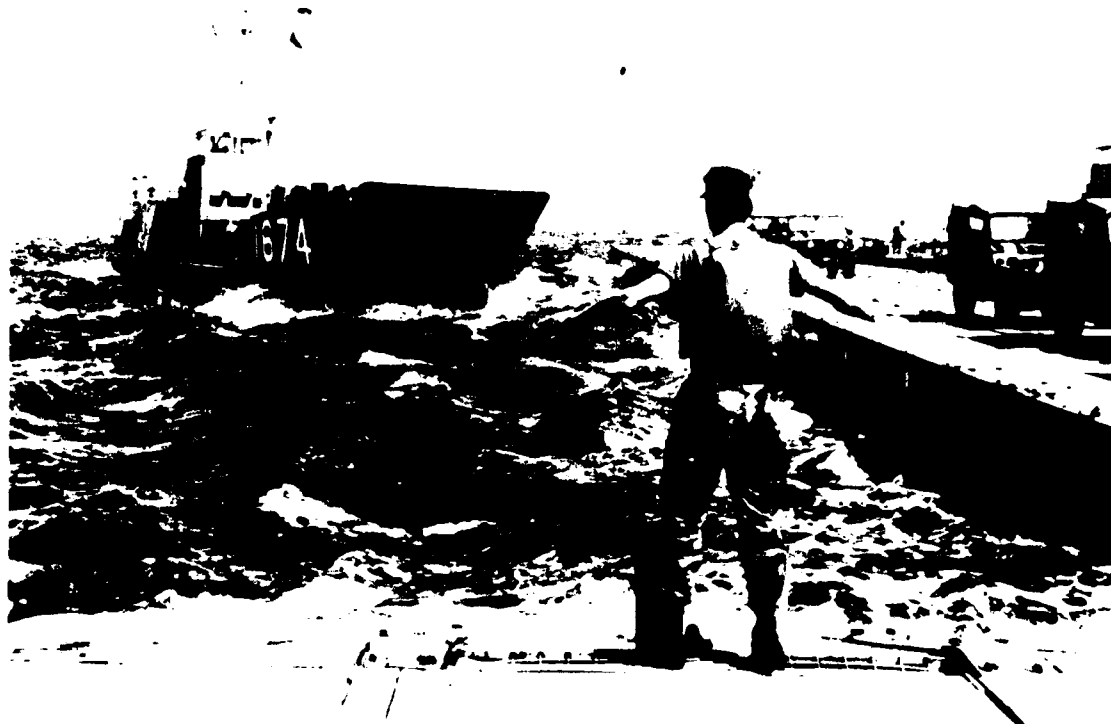
Figure 47 - LCU Approaching B Section

1. As concluded in earlier tests⁵ it was found that Causeway Ferries and LCUs can be readily married to the CPF under calm sea conditions (Sea State 0-1). As winds and seas increase, the presence of a Causeway Ferry already married eases the marriage of additional ferries or an LCU (Figure 47).

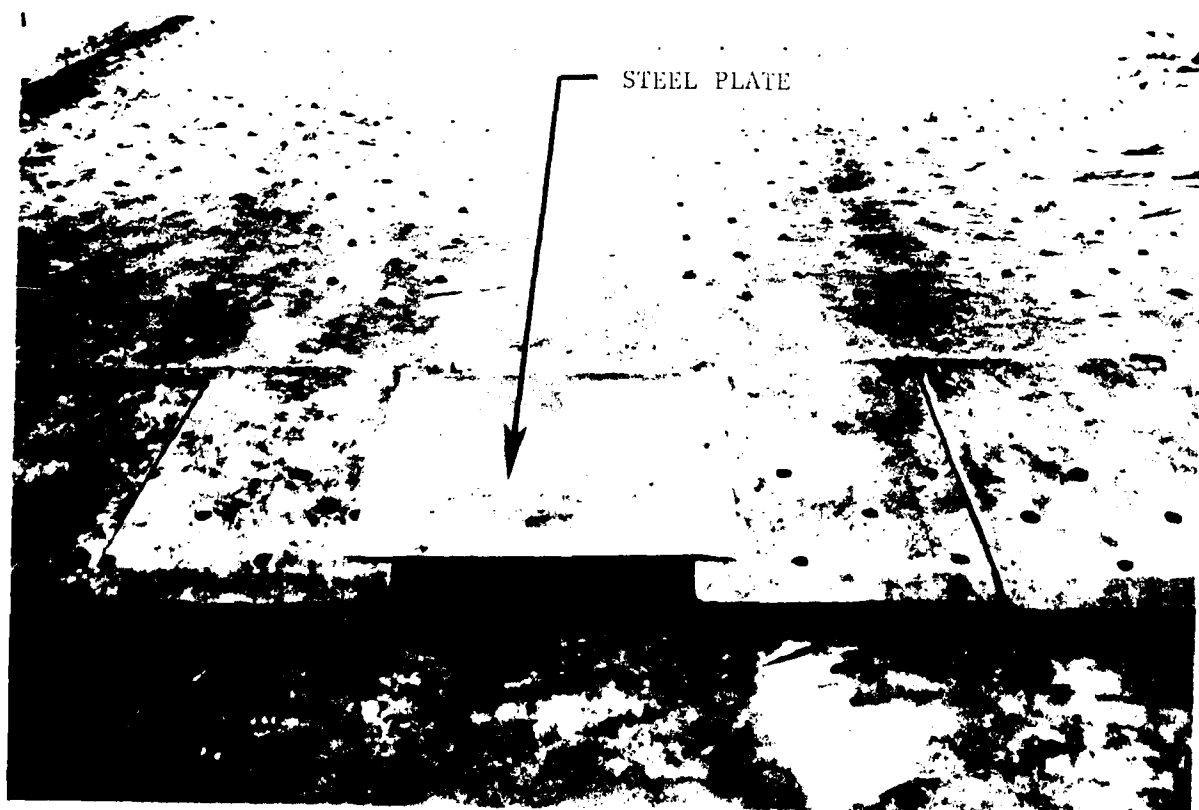
Figure 48 - CWR Vehicle Flaps at Ship

Test Results. No difficulties were encountered during offloading operations. On one occasion a jeep's wheel rolled into the small space in the middle of the CWR between the CWR to ship flaps. This space was also a safety hazard for traffic directors who could step into it. A steel plate was welded to one of the adjacent flaps to eliminate the problem (Figure 48). All of the test vehicles were offloaded with no difficulty (Figure 49).

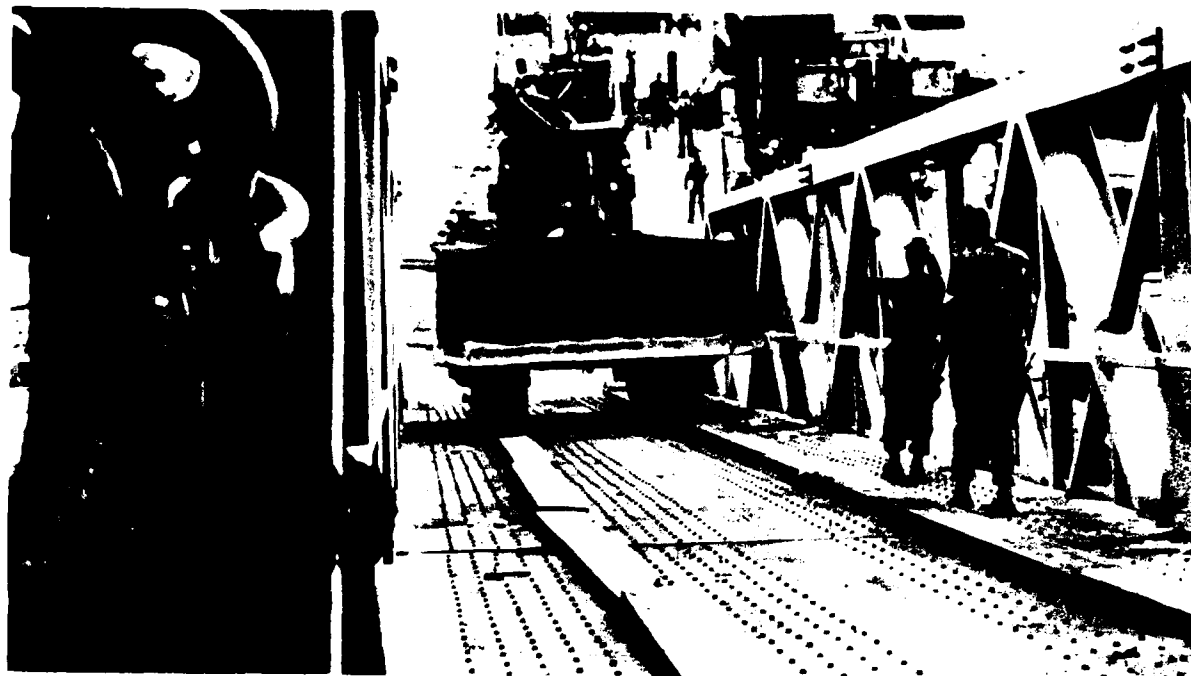
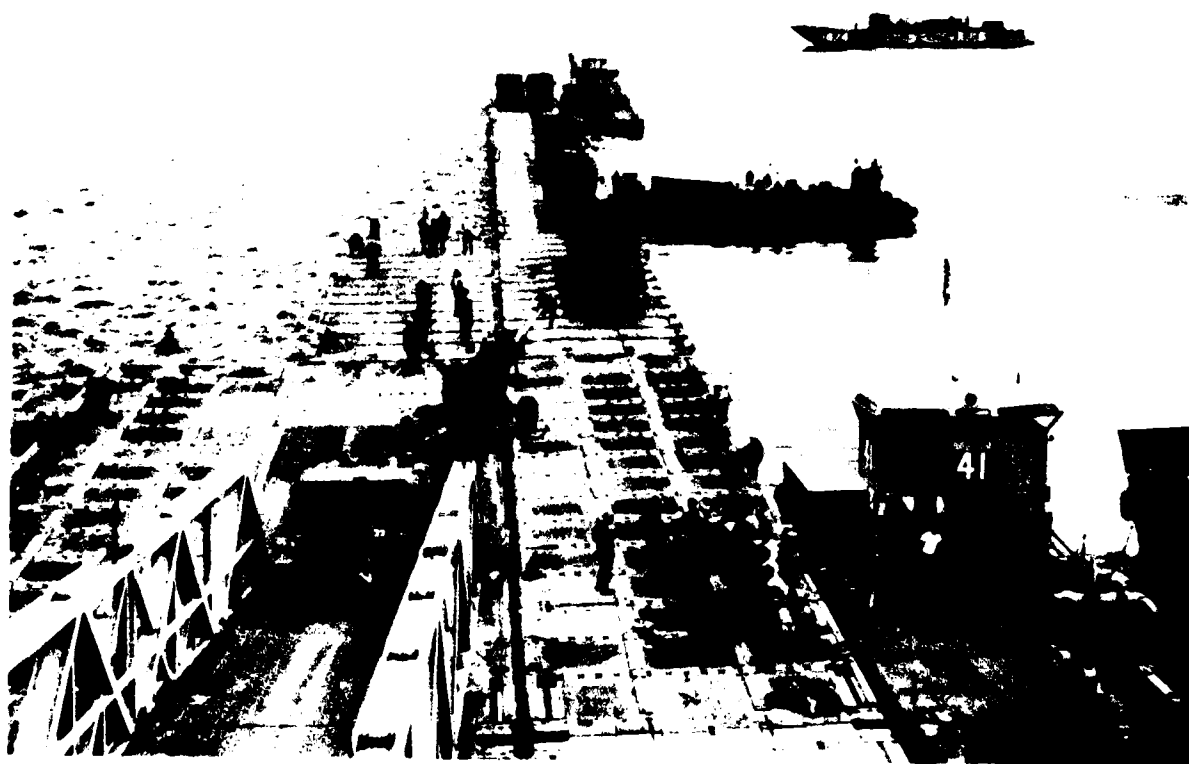
Figure 50 - Vehicle Retrograde Onto SS ATLANTIC BEAR

Test Results. Vehicle performance was satisfactory throughout the test. Ramp angle was 11 deg (Figures 49 and 50).
